## Pleasant View Church & Quince Orchard Schoolhouse

*Pleasant View Historical Association*  
*North Potomac, Maryland*  
Structural Condition Assessment

Prepared For:  
Preservation Maryland

April 14, 2016

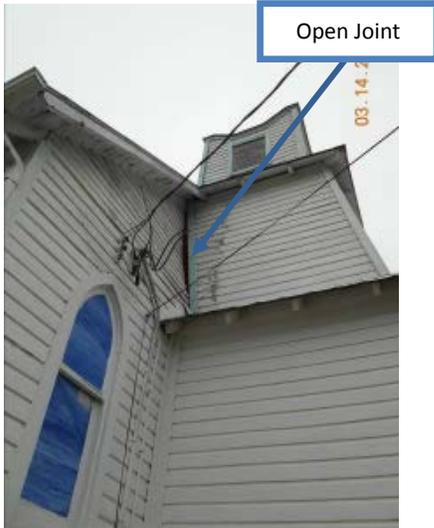
Figure 2: Main Church and Bell Tower Separation.

The bell tower structure and main entrance concrete steps have settled and pulled away from the main church structure (Figure 2). Settlement cracks are visible in the concrete piers supporting the north elevation of the bell tower structure (Figure 3).

- *Remove clapboard siding for review of the bell tower structural framing. Framing shall be reevaluated for review when opened and rebuilt as required to reestablish connection of bell tower to main building structure.*
- *Provide new concrete piers to lift and level bell tower floor framing. Piers shall extend below frost depth.*
- *Provide new concrete main entrance steps and sidewalks. Alternatively, the existing deteriorated concrete may be removed. Following removal, all existing concrete shall be cleaned and patched as required.*
- *Regrading the site to provide positive drainage away from the building exterior walls.*
- *Reroof the main church and bell tower structures to ensure a watertight system. Reevaluate bell tower framing when opened for review. Provide an*

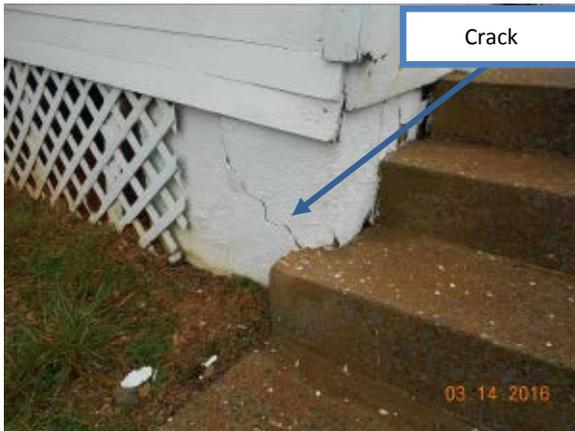
Figure 3: Concrete Pier Settlement

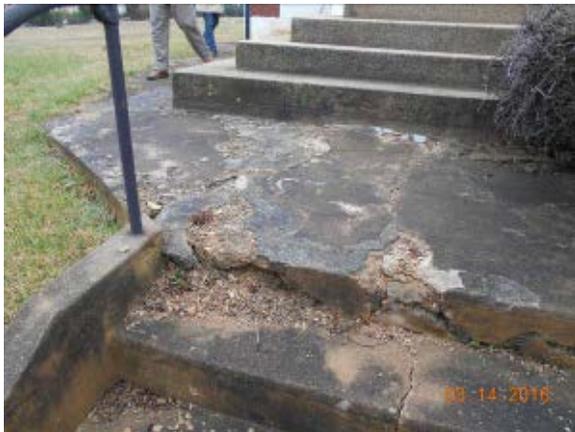
Significant concrete deterioration and settlement was observed at the main entrance steps (Figure 4).

Figure 4: Concrete Distress @ Main Entrance Steps.

- Priorities:
  - I. Pleasant View Church (*Please reference Sections 5.1.1 and 5.1.2*)
    1. Provide new concrete piers at bell tower to level framing. Provide new concrete entrance steps and east elevation side walk.

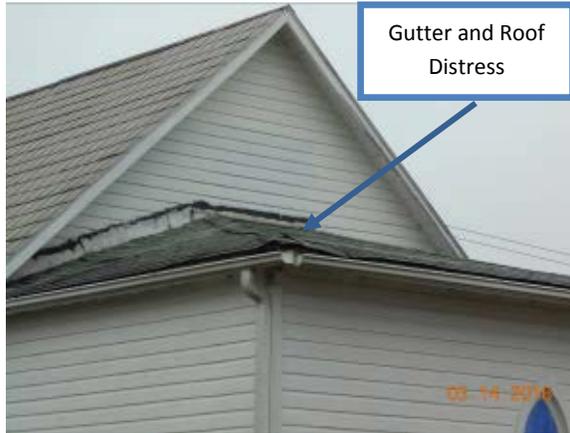
The existing roofing and gutter system is in disrepair thereby allowing water to infiltrate the building at the roof elevation and perimeter walls (Figure 5). Existing down spouts were observed to deposit water at the base of the exterior walls (Figure 6). Furthermore the site has negative slope (site slopes towards the building walls) allowing site runoff to accumulate at the base of the exterior walls.

Figure 5: Roof and Gutter Distress.

- *Review of the functional capacity of the existing gutter and drainage system for building size. The existing system shall be modified/cleaned as required to adequately conduct rainwater away from the building foundations.*

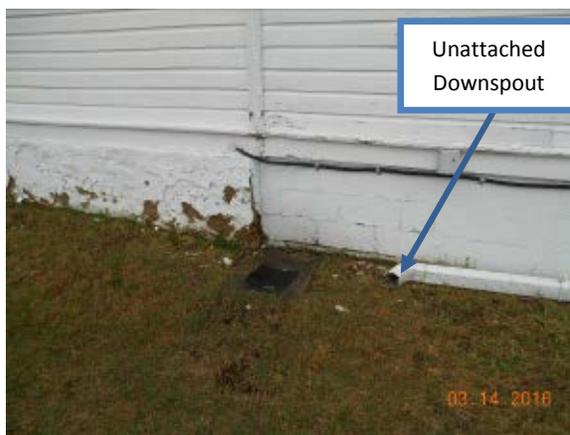
Figure 6: Unattached Downspout.

- *Secure all downspout extensions to lead well away from the building foundations. As part of a later phase downspouts may lead into a new perimeter foundation drainage system. Parge exterior perimeter walls below grade. Please note a new perimeter drainage system would require excavation around the entire building perimeter.*

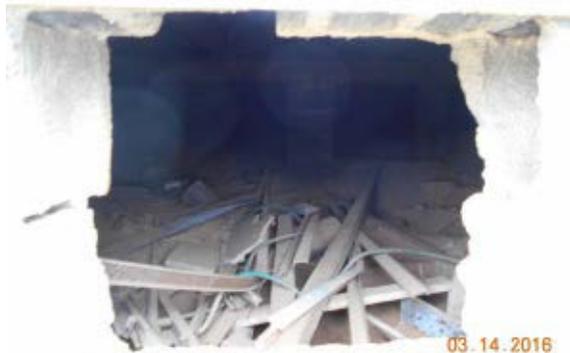
An unprotected opening in the 1940's concrete masonry foundation wall was observed allowing debris accumulation and easy access for vermin (Figure 7).

Figure 7: 1940's Foundation Unprotected Opening.

- *Provide louver cover at all foundation wall openings to deter critter access and debris accumulation.*
- *Clean and paint existing railing system with corrosive resistant paint. Provide concrete patch repair to reestablish sufficient railing attachment connection to concrete slab and supporting concrete masonry walls at east elevation 1940's access stairs.*

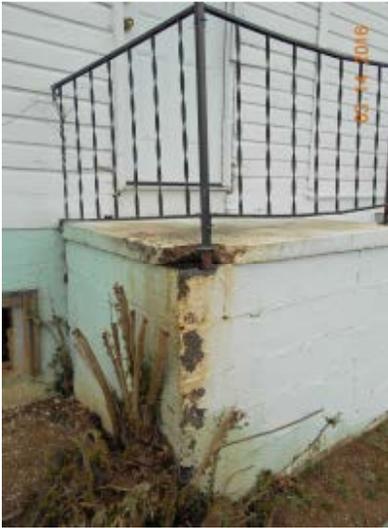
The 1940's east elevation railing attachment was observed to be unconnected to the supporting structure due to rust jacking and spalled concrete (Figure 8).

Figure 8: Spalled Railing Attachment.

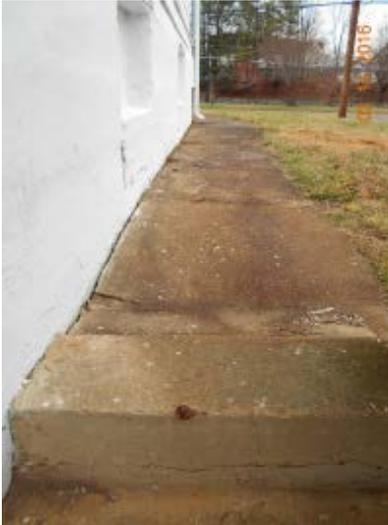
at existing wood shed roof framing. Distress was observed at the east elevation side walk in the form of settlement, concrete spalls and cracks (Figure 9).

Figure 9: East Elevation Sidewalk Distress.

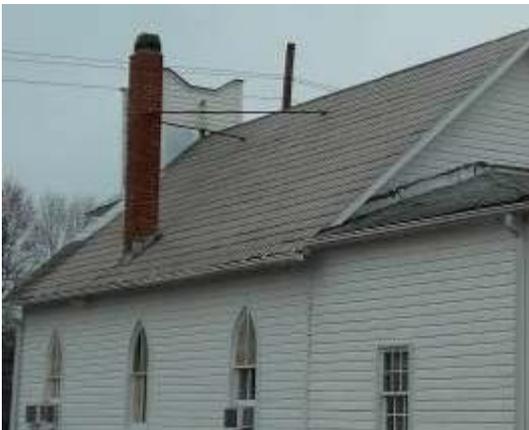
Mortar loss was observed at the existing chimney stack located on the west elevation of the building (Figure 10). A chimney vent cap was not observed.

Figure 10: Deteriorated Mortar Joints @ Existing Chimney

- *Remove all existing insect nests and deteriorated timber framing. Reroof the east elevation access stair shed as needed.*
- *Repoint existing chimney mortar joints with compatible mortar.*

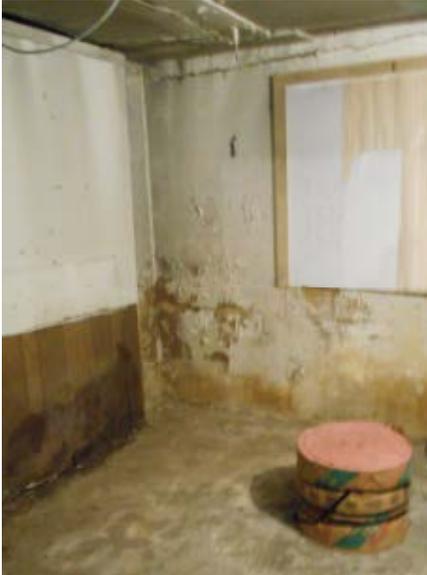
**Figure 11: Rising Damp @ Interior Basement Walls.**

Significant moisture distress was observed within the main church basement. Interior walls exhibited signs of rising damp (Figure 11). Moisture staining and standing water was present on the existing concrete basement slab (Figure 12).

- *Repairs to the roof, gutter, and drainage system will further reduce the extent of moisture infiltration within the basement. Furthermore, as part of a future phase (low priority), provision of perimeter foundation drainage system and parging exterior walls below grade will help reduce the extent of moisture infiltration within the basement.*
- *Engagement of a pest control expert to determine presence of termites while establishing a maintenance control contract for long-term pest control.*
- *Provide corrosive resistant post base at base of timber posts to elevate posts above standing water.*
- *Infill interior basement stair opening to eliminate current fall risk.*
- *Window surrounds shall be evaluated, resealed and calked as required to reestablish building envelope. Replace cracked window pains and repair interior wall finishes as required.*

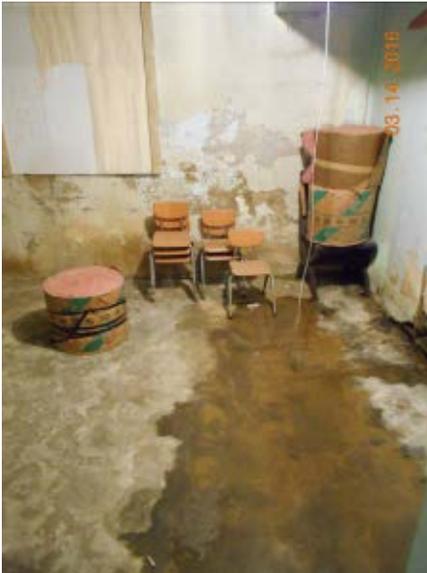
**Figure 12: Standing Water and Moisture Staining @ Basement slab.**

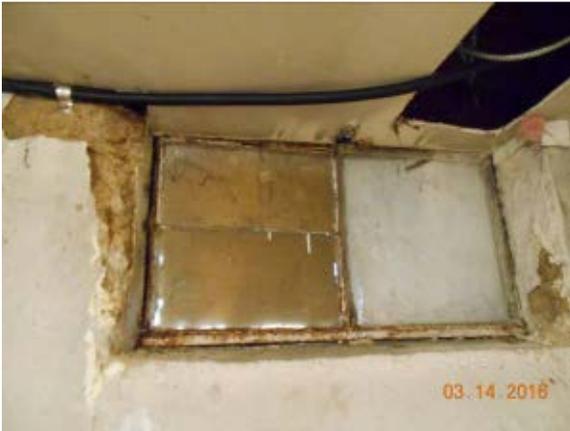
Moisture infiltration is apparent at window surrounds within the basement (Figure 13).

Figure 13: Moisture Distress @ Basement Window Surrounds.

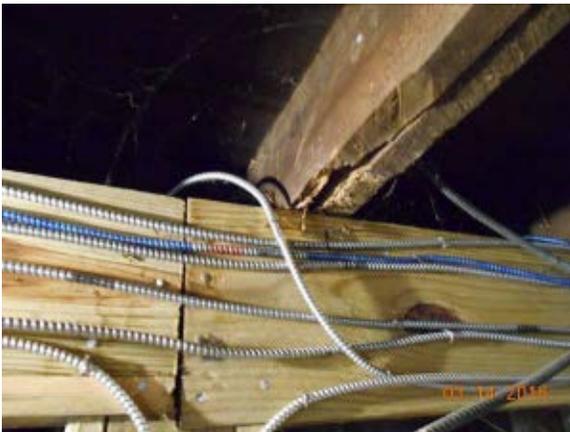
Existing termite distress was apparent at existing floor joists. Supplemental support in the form of a timber girder supported on timber posts was provided at midspan to support existing joists (Figure 14). The base of the timber frame posts rests directly on top of the existing concrete slab and is exposed to standing water (Figure 15).

Figure 14: Existing Termite Distress @ Floor Joists

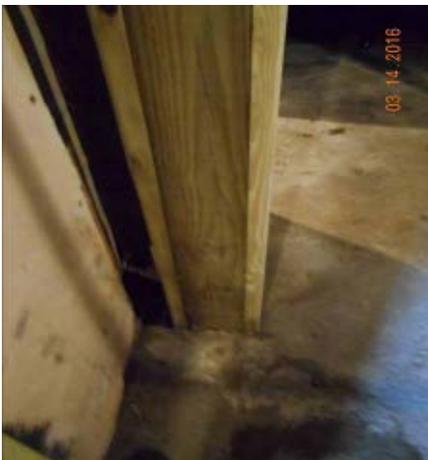
Figure 15: Timber Frame Post Bearing @ Basement Slab.

7. Remove insect nests within and around entire building perimeter.
    8. Engagement of pest control expert.
    9. Provide corrosive resistant post base at basement timber posts.

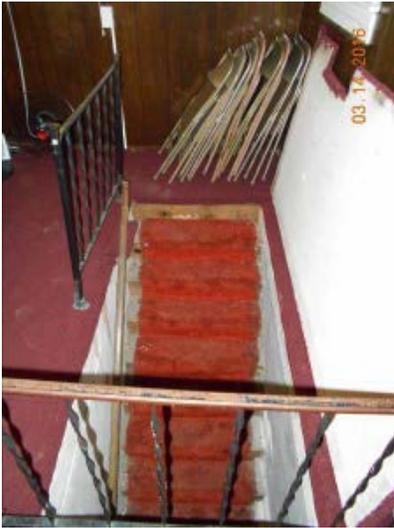
The interior basement access stair guardrail is missing in one location and the remaining guardrails are insufficient to provide code required restraint (Figure 16). K&H understands the existing interior basement access stairs are to be removed and the floor infilled as part of future building repairs.

Figure 16: Interior Basement Access Stairs.

13. Infill interior basement stair opening.

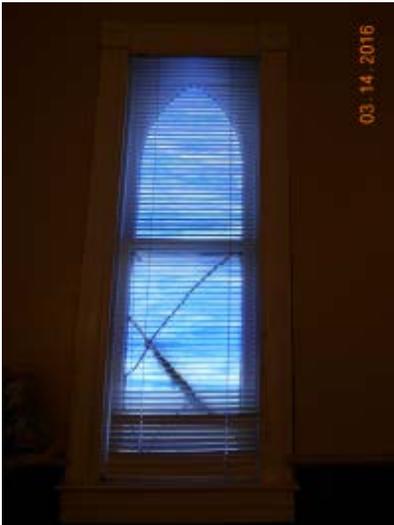
Cracking of the existing window panes was observed (Figure 17).

Figure 17: Cracked Window Panes.

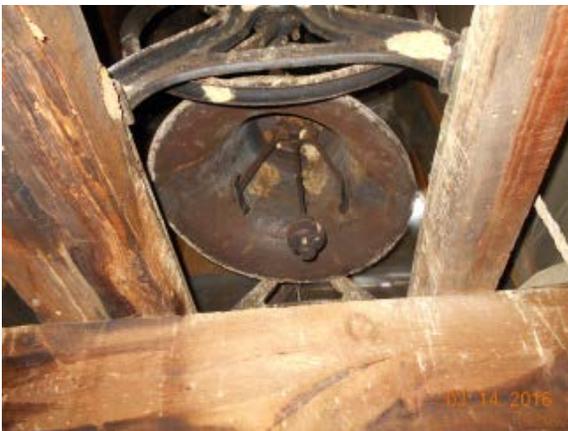
Moisture staining and structural member deterioration was evident within the bell tower timber framing. Moisture staining was apparent at the bell tower drop ceiling panels

(Figure 18). Daylight was visible between the bell tower roof structure and the main church structure.

Figure 18: Bell Tower Framing Deterioration.

- Evaluate existing interior bell tower framing when opened for review. Provide positive anchorage of existing bell tower frame back to main church structure through use of Simpson strap anchors similar. Provide allowance for limited wood framing repairs at the bell and roof framing levels.
- Sister in kind deteriorated wood roof framing within the main church structure. Provide allowance for limited wood replacement in kind primarily located along roof eave conditions.
- Remove insect nests within main church attic and bell tower structures.

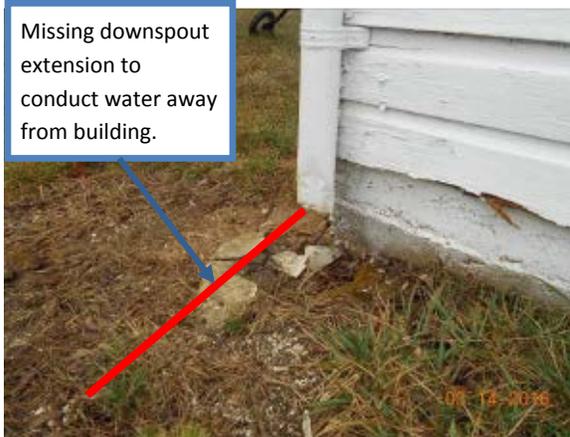
Figure 19: Inadequate downspout termination at base of wall.

The existing gutter system is in disrepair allowing runoff from the roof to settle adjacent to exterior walls. Existing down spouts were observed to deposit water at the base of the exterior walls (Figure 19). Furthermore the site has negative slope (site slopes towards the building walls) allowing site runoff to accumulate at the base of the exterior walls (Figure 20).

- *Regrading the site to provide positive drainage away from the building exterior walls.*
  - *Secure all downspout extensions to lead well away from the building walls.*

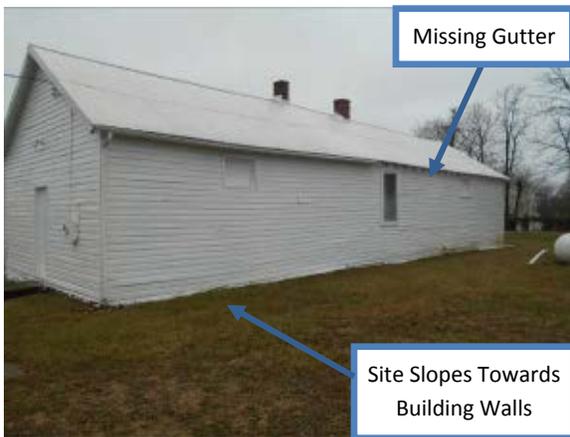
Figure 20: West Elevation Missing Gutter.

- *Review of the functional capacity of the existing gutter and drainage system for building size be conducted. The existing system shall be modified/cleaned as required to adequately conduct rainwater away from the building foundations.*

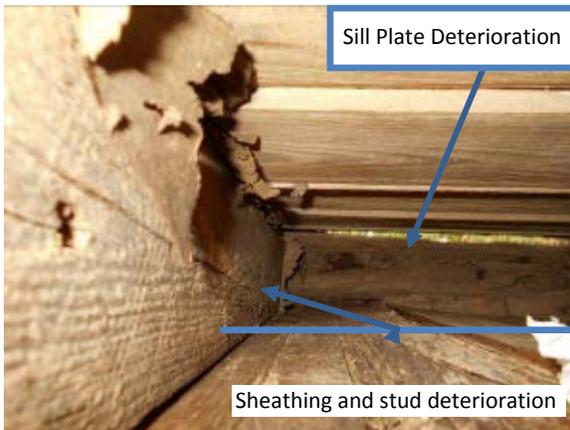
Figure 21: Deteriorated Wood Framing @ Base of Exterior Wall.

Moisture staining was evident at the base of the exterior wood framed walls. The existing timber walls and floor framing appear to be in contact with the ground in most locations allowing runoff water to be wicked through the walls and floor framing. As such the existing timber framing has deteriorated from moisture infiltration (Figure 21). Additional moisture staining was observed at window surrounds.

- *Underpin full length of north elevation rubble stone wall.*
  - *Existing wall framing shall be opened for review. All deteriorated framing shall be sistered or replaced in kind. Install vapor barrier where existing clapboard siding is removed to evaluate sill plate.*

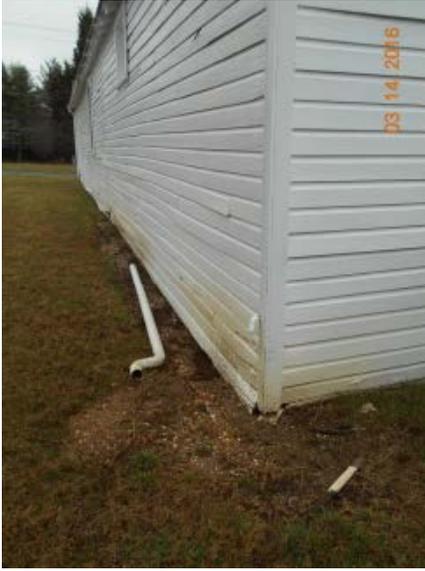
The existing concrete foundation, where present does not extend to frost depth. Bowing of the exterior walls was observed along each elevation. As such, the exterior walls have experienced significant deformation as a result of frost heave and foundation settlement (Figure 22).

Figure 22: West Elevation Wall Displacement.

- *Installation of new concrete piers at routine spacing (approximately 10 feet on center) to extend foundation to frost depth (2'-6" below top of grade). Installation of intermediate piers will prevent excavation around South, East and West Elevations.*

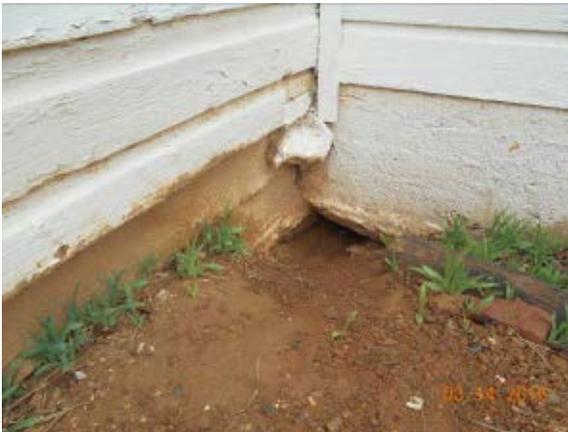
The shallow foundations have allowed for vermin to burrow and nest beneath the school house (Figure 23).

Figure 23: Undermined existing foundation wall.

- *Engagement of a pest control expert to relocate existing vermin while establishing a maintenance control contract for long-term pest control.*
  - *Repoint existing chimney above roof elevation with compatible mortar.*

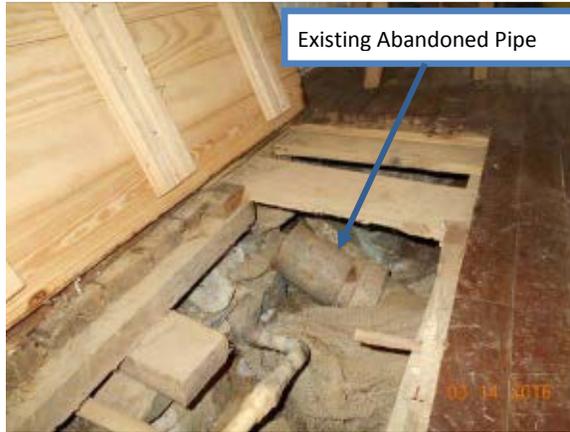
Figure 24: Crawl Space & Abandoned Pipe.

A floor access hatch located adjacent to the north exterior wall was opened for review of the foundation and floor framing elements. An abandoned pipe was observed within the space (Figure 24).

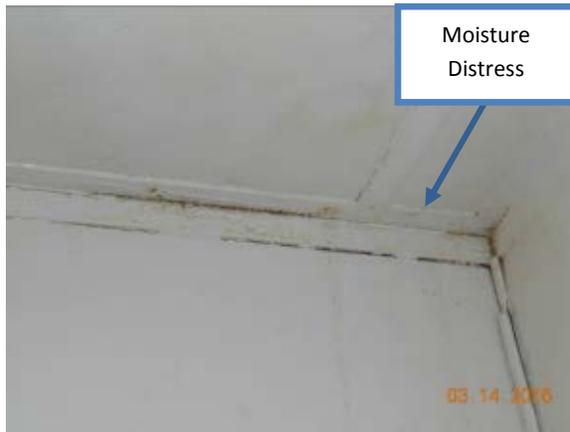
Figure 25: Moisture Distress @ Interior Walls.

Moisture distress was observed at interior wall finishes and at window surrounds (Figure 25). In addition biological growth was observed on the interior face of the west exterior wall in the north classroom. The existing roof framing was observed at one location in the men's restroom and appeared to be in good condition.

- *Provide crawl space ventilation through floor vents or louvers in the perimeter foundation wall.*
- *At areas where moisture distress is observed at wall finishes, remove existing finishes to evaluate structural framing.*
- *Window surrounds shall be evaluated, resealed and calked as required to reestablish building envelope.*

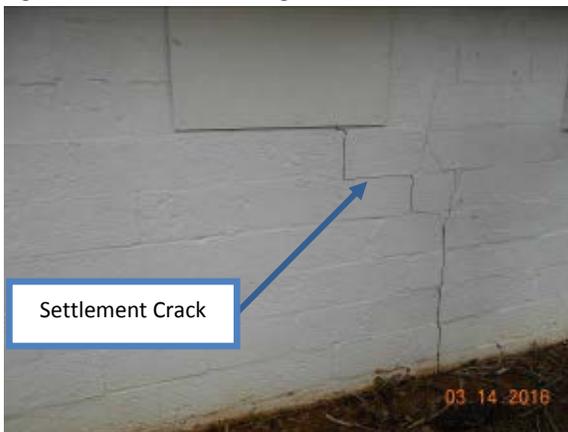
Figure 27: South Elevation Settlement Cracks.

Overall the structure appears to be in good condition with minor settlement cracks at the south concrete masonry wall (Figure 27).

- *Repointing existing cracked mortar joints with a compatible mortar.*
  - *Removal of debris and water from vault space for inspection. Evaluate underside of existing slab following debris removal. Furthermore, K&H recommends a vented cover for the vault be provided to eliminate a potential fall hazard.*
- *Crack repair of the existing concrete slab may be required following review of existing interior building conditions.*
  - *Provide bird screening at roof to deter nesting and interior access to the building.*
