Applying Infrared Thermography (IRT) to Detect Deterioration and Anomalies in Adobe Masonry **Field Manual, Equipment List, and Case Study Results**

Sara Stratte
June 2021

Completed with the support of the Harrison Goodall Preservation Fellowship.

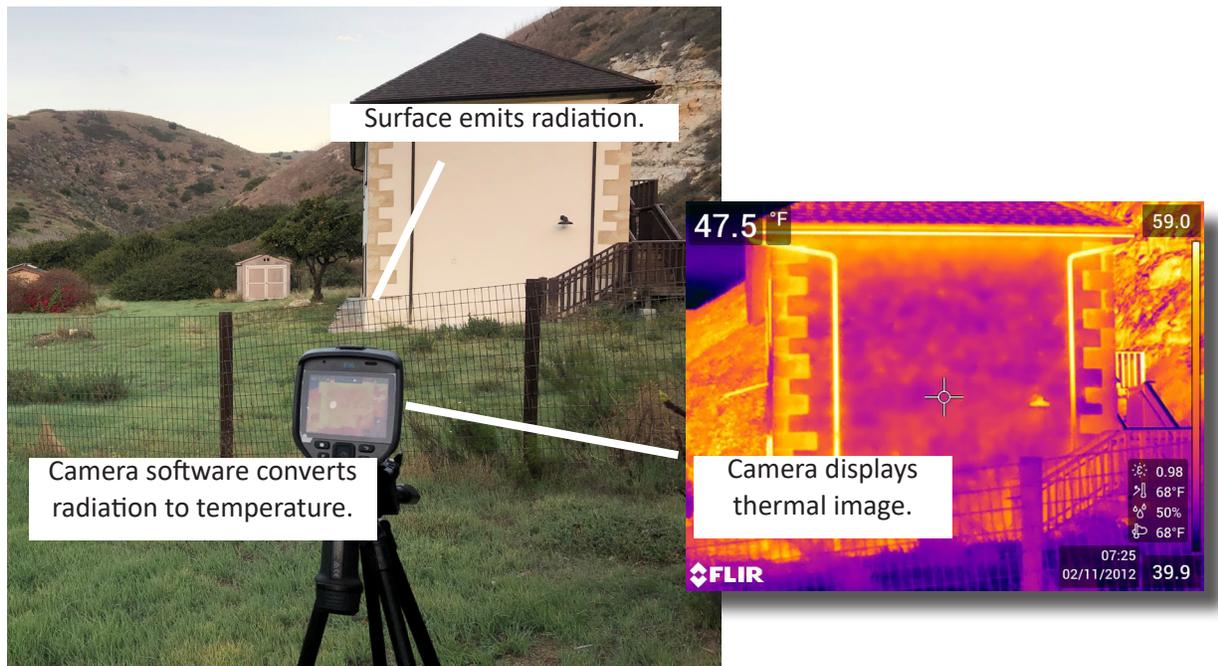
FIGURE 1. A simplified infographic to demonstrate how infrared cameras translate acquired data into thermal images.

Infrared thermography (IRT) investigation is a remote measuring technique which maps the distribution of radiation emitted from a surface. IRT investigation relies on the use of an infrared camera, which has sensors that can record infrared radiation emitted from an object surface and interprets that radiation into a thermal image. This operates based on the principles that 1) all objects above the temperature 0 degrees Kelvin emit infrared radiation and 2) the infrared radiation emitted from its surface is related to its temperature.

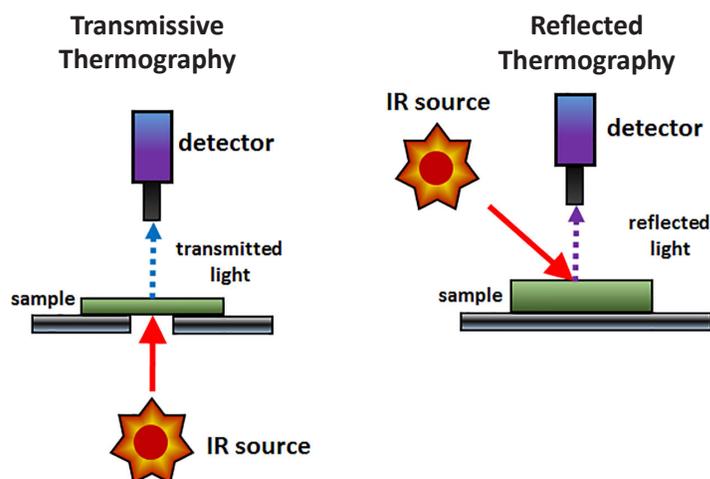
FIGURE 2. The two methods of positioning the camera and external heat source for Active Thermography.

- *Reflected thermography* describes applying thermal excitation (i.e. a heat source) directly to the surface which is in the thermal camera's field of view (Figure 2). This is typically easier to complete in the field, as the opposite site of the surface is not always accessible.
- *Transmissive thermography* describes a method of active thermography in which the thermal excitation is applied to the surface opposite from the surface which is in the thermal camera's field of view (Figure 2). Ideally, the energy from the source on the opposite side of the feature from the camera will travel through the material. A common example of this concept is thermal cameras to

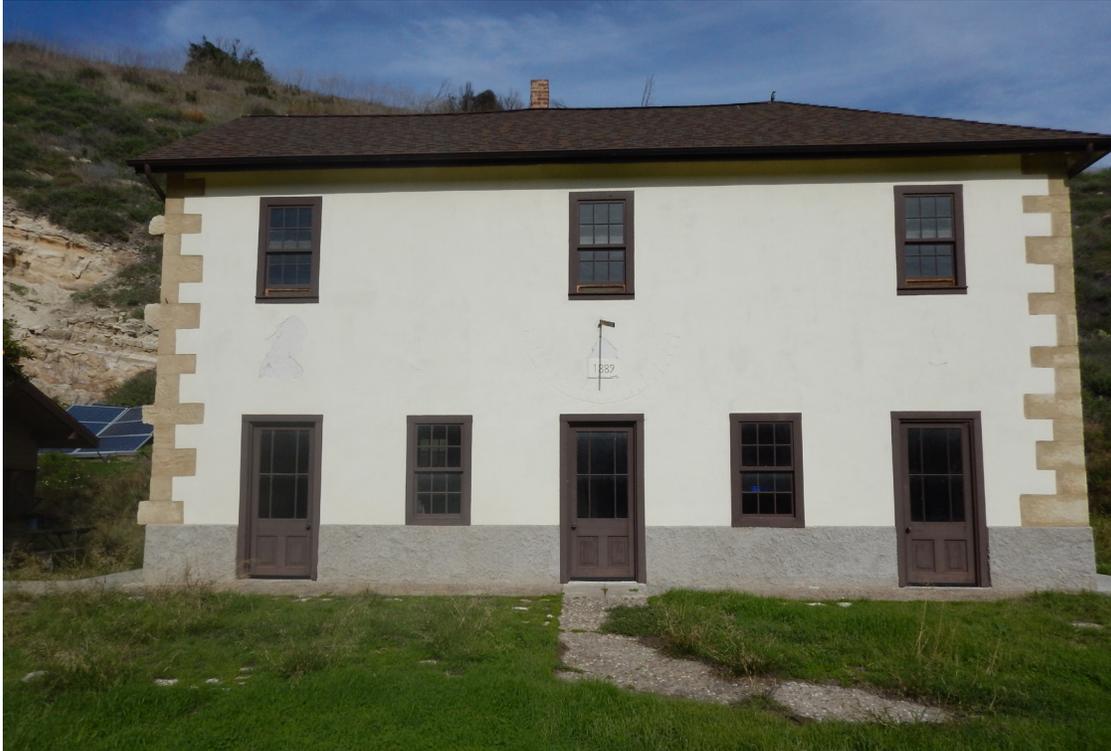
FIGURE 4. South elevation and principle façade of the Smugglers Adobe.

The Smugglers Adobe Ranch House was built in the late nineteenth century to support sheep ranching and farming on Santa Cruz Island off the coast of Southern California (Figure 3-4). The house, which is colloquially called Smugglers Adobe, is built of local stone and adobe with thick walls (15-20") on a stone foundation. The structure measures 21 by 40 feet and is two-stories. The exterior of the structure is stuccoed with lime plaster and lime washed, and the builders incised a sundial in the stucco above the central doorway (Figure 5). In 2011, the National Park Service completed a rehabilitation project, which included restoring exterior finishes and installing a concrete bond beam for seismic safety compliance. In 2018, the structure suffered minor damage due to a nearby earthquake, and this damage has not been subsequently repaired.

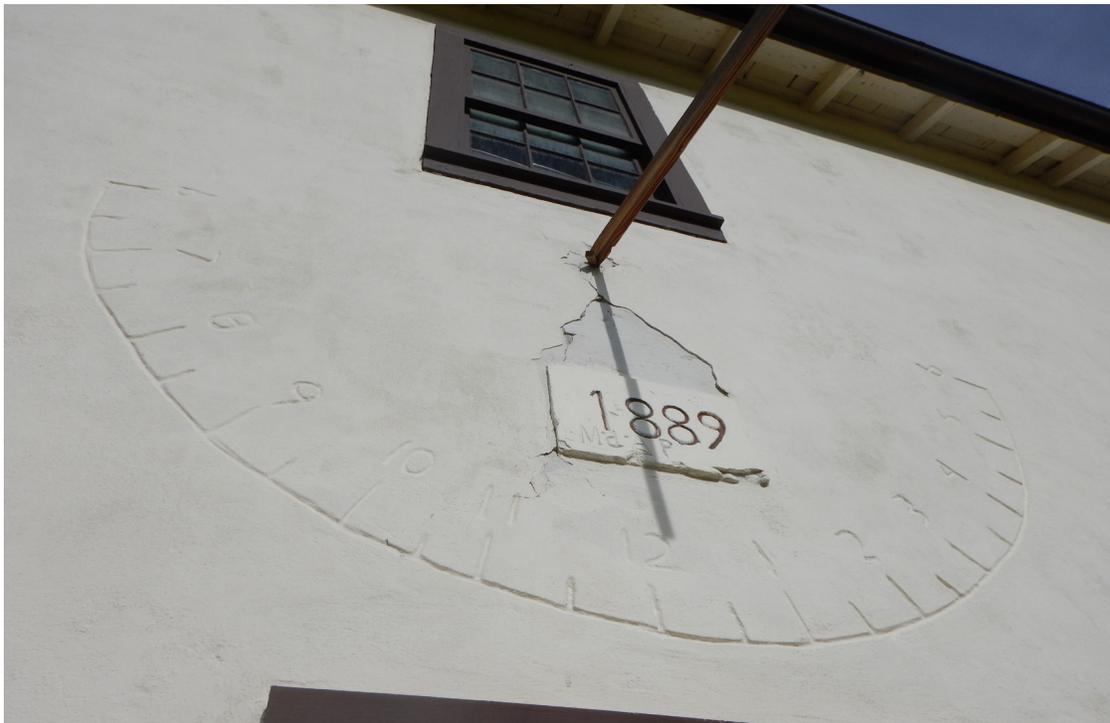
FIGURE 5. Above the principle doorway, the builders incised a sundial in the plaster. Based on historic photos, this detail is assumed to be original to the structure.

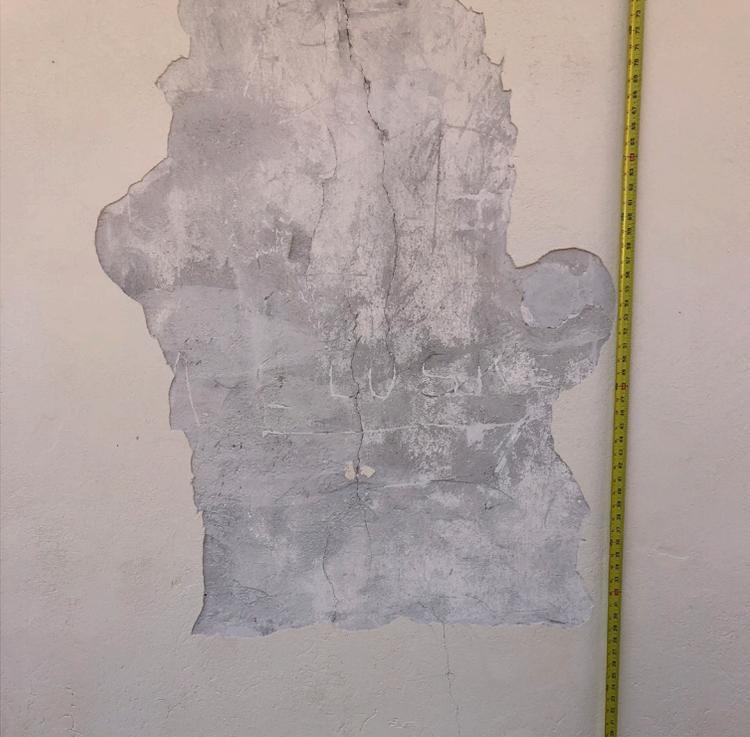
Condition and Description	Photo Example
<p>Detachment of Exterior Plaster from Adobe/Stone Masonry</p> <p><i>Debonding or detachment of the coarse coat (not historic) from the masonry. At present, this condition is a “blind condition,” or not visible to the naked eye.</i></p>

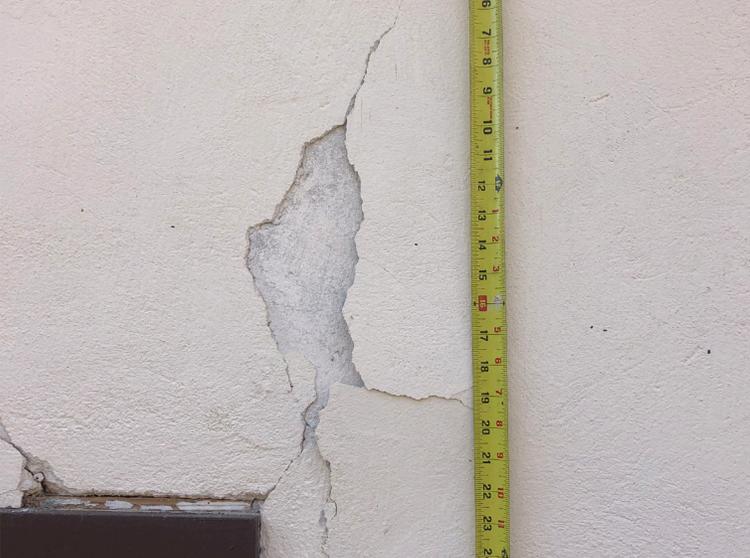
<p>Detachment of Skim Coat from Coarse Plaster</p> <p><i>Debonding or detachment of the skim coat (not historic) from the underlying plaster. This condition either coincides with some cracking or a blind condition (not visible)</i></p>

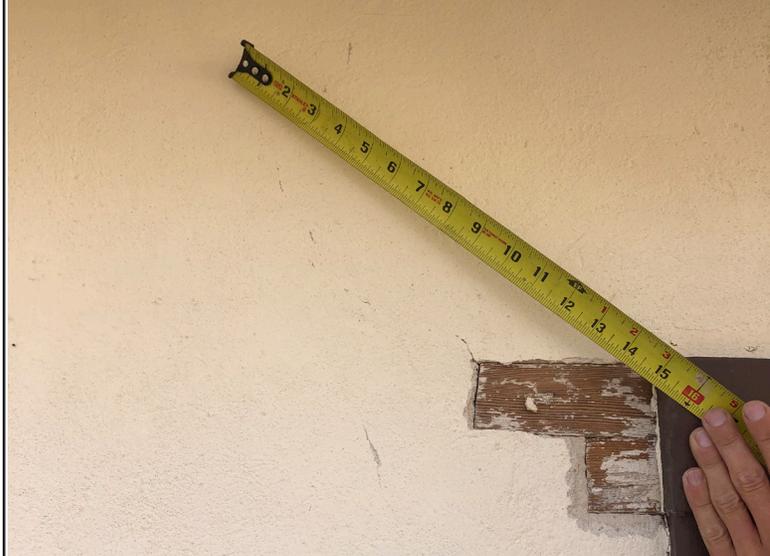
<p>Cracking</p> <p><i>Discontinuities in historic plaster, non-historic coarse plaster coat or skim coat rendering (also not historic). Cracks are the result of movement during the 2018 seismic event, although some cracks may have been previously existant and repaired during the 2011 rehabilitation project.</i></p>

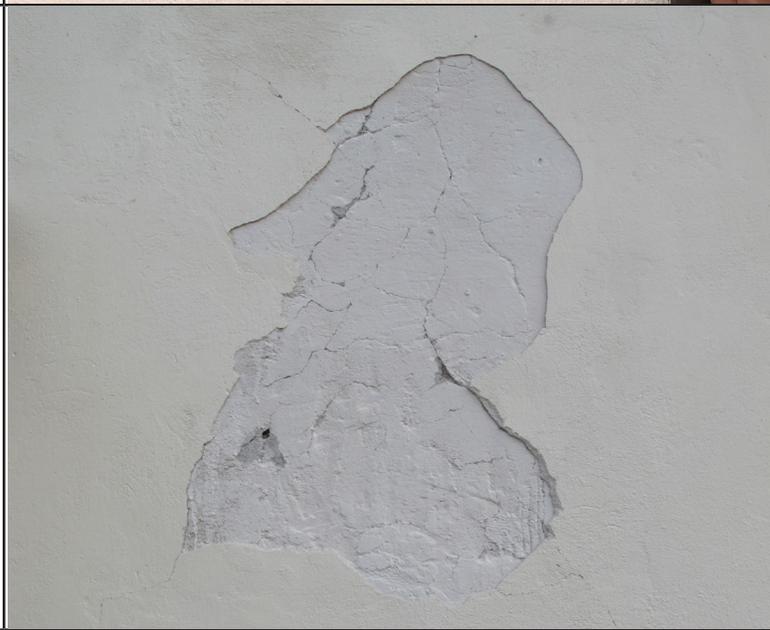
<p>Loss of Skim Coat</p> <p><i>Loss of the exterior skim coat rendering (not historic); largely the result of movement during the 2018 seismic event.</i></p>

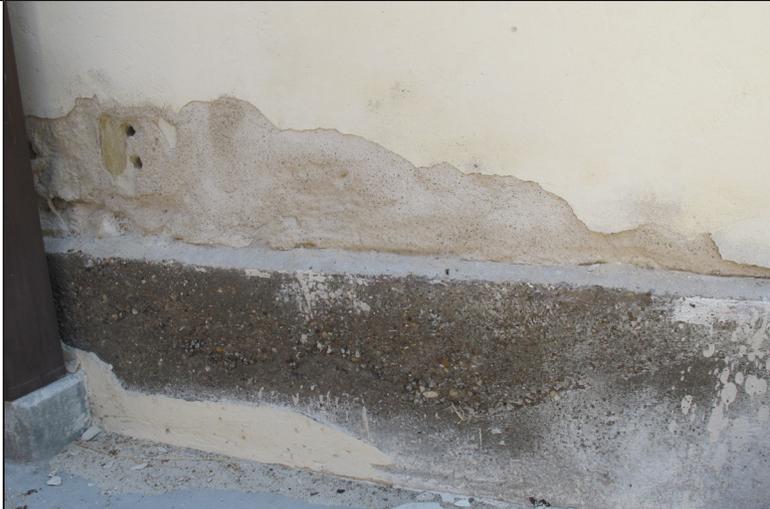
<p>Basal Damage due to Moisture Infiltration</p> <p><i>Moisture rises up through the base of the wall due to capillary action. Evaporation of the moisture causes the materials to disintegrate.</i></p>

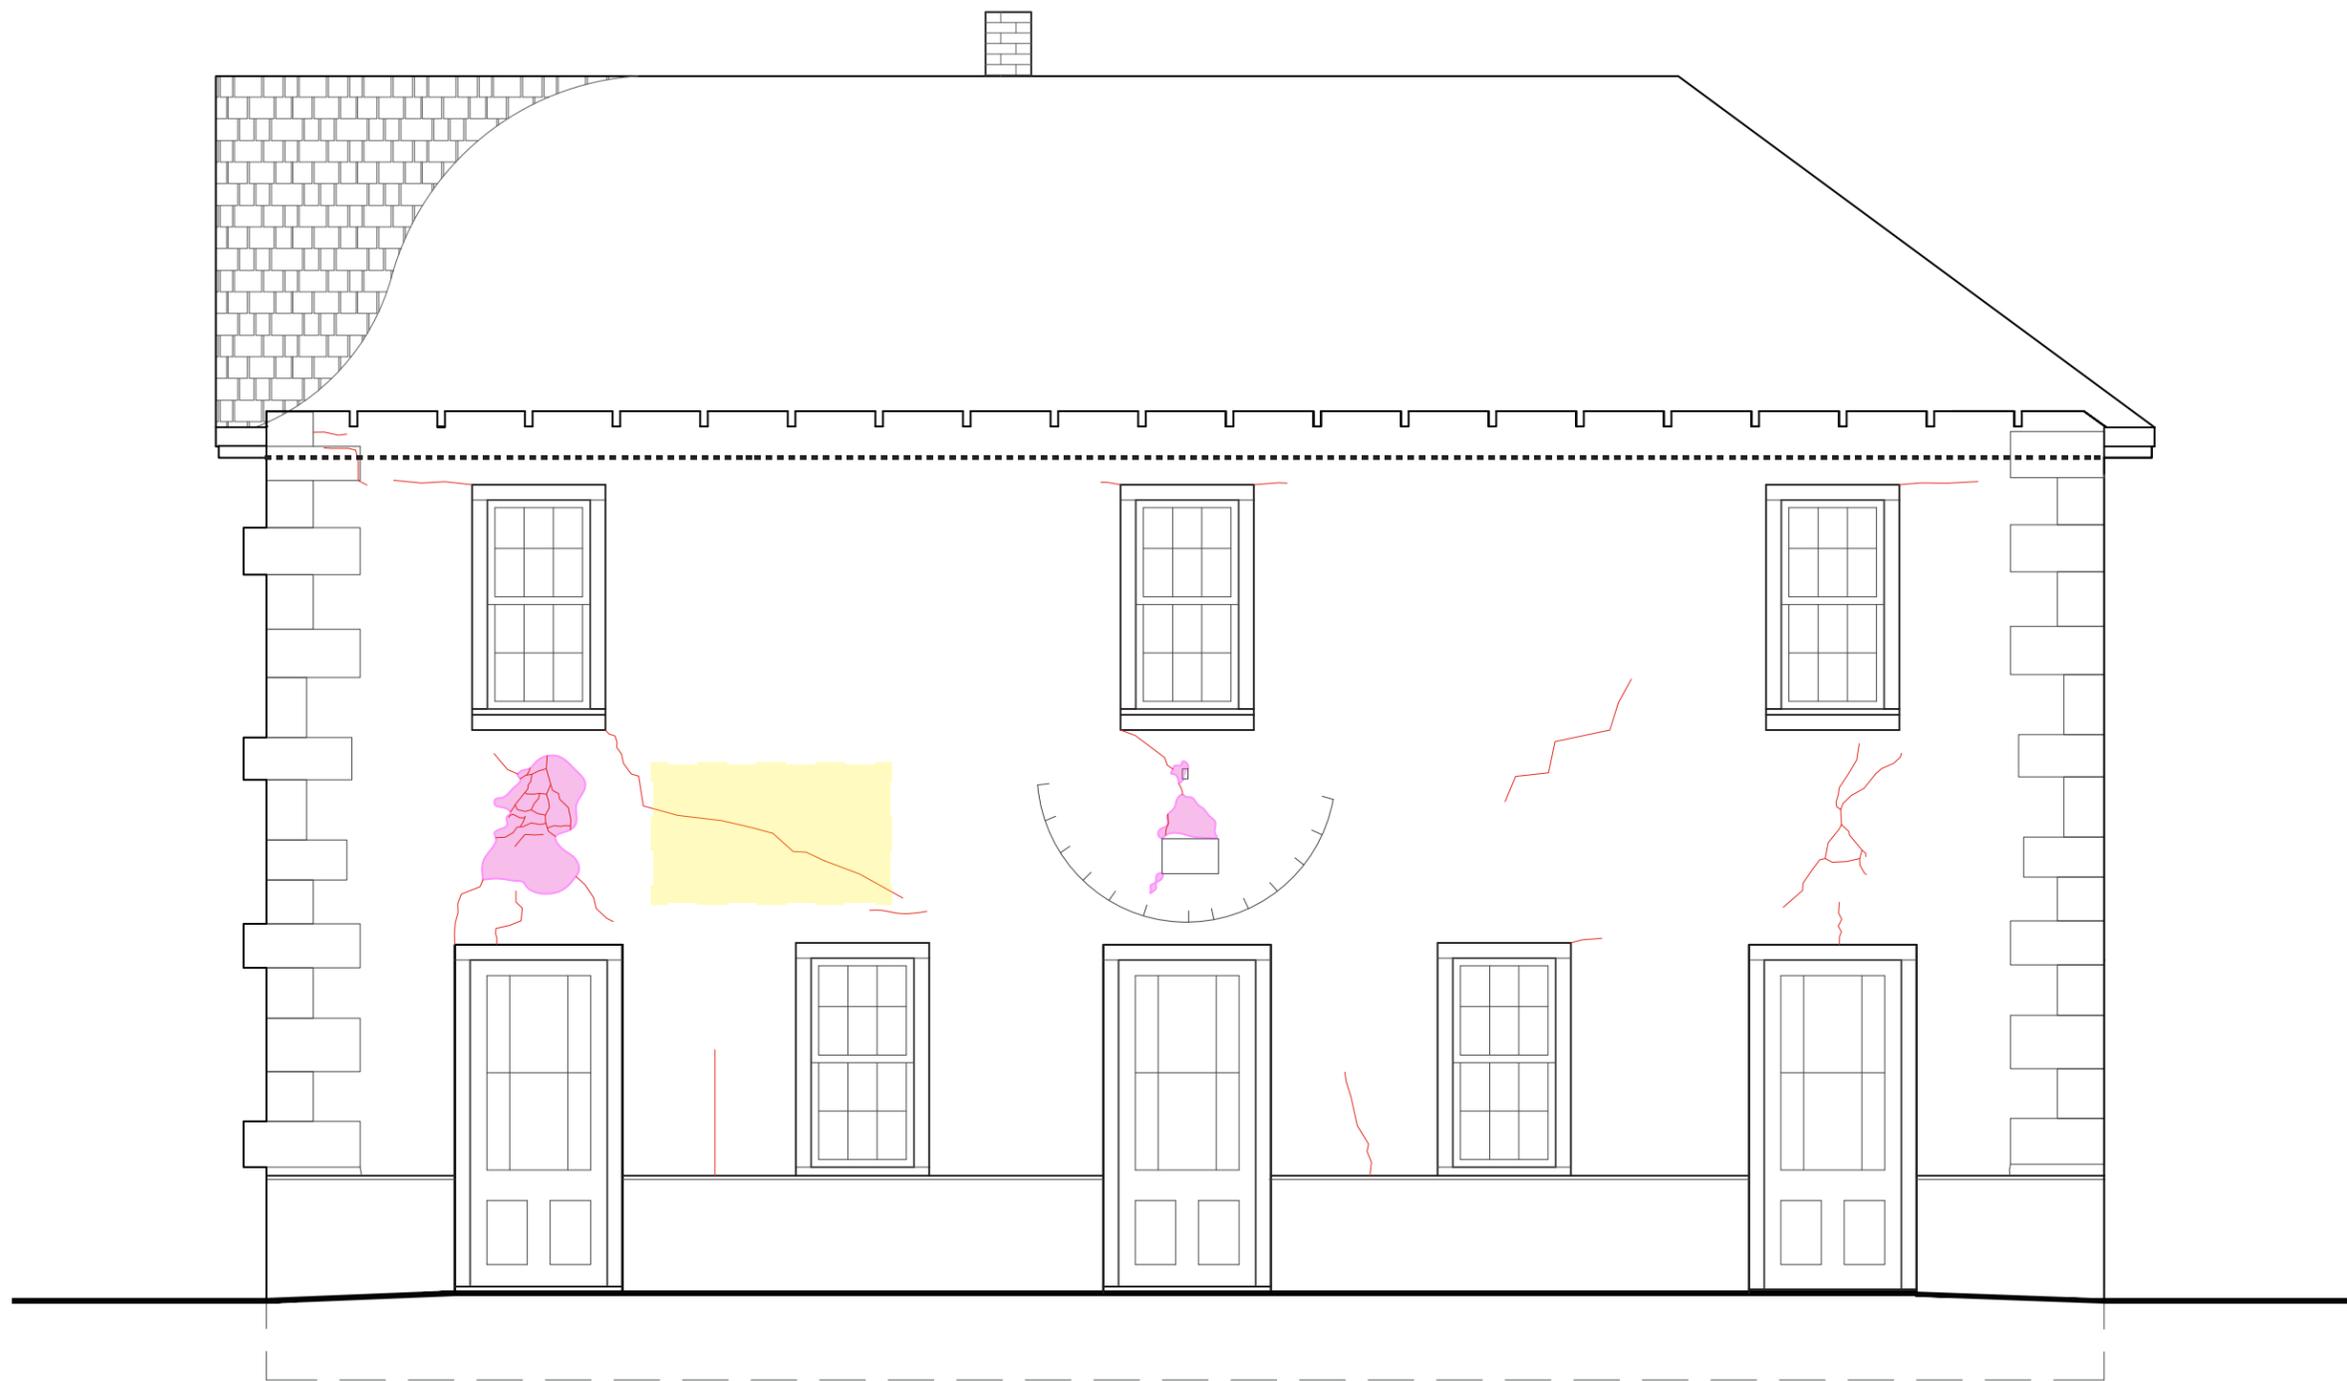
TITLE OF SHEET:
CONDITIONS DRAWINGS
South Elevation

CONDITIONS DENOTED IN THESE
DRAWINGS ARE BASED ON VISUAL
SURVEY ONLY.

- Detachment of exterior coarse plaster from the underlying adobe and/or stone masonry.
- Detachment of the exterior skim coat (from the 2011 rehabilitation campaign) from the underlying coarse plaster.
- Cracking of the plaster system (both superficial cracking of the skim coat and cracks through the plaster).
- Loss of the exterior skim coat.
- Basal damage due to moisture on the west elevation (See Table 4 for conditions definitions and the following conditions drawings on pages 20-22).

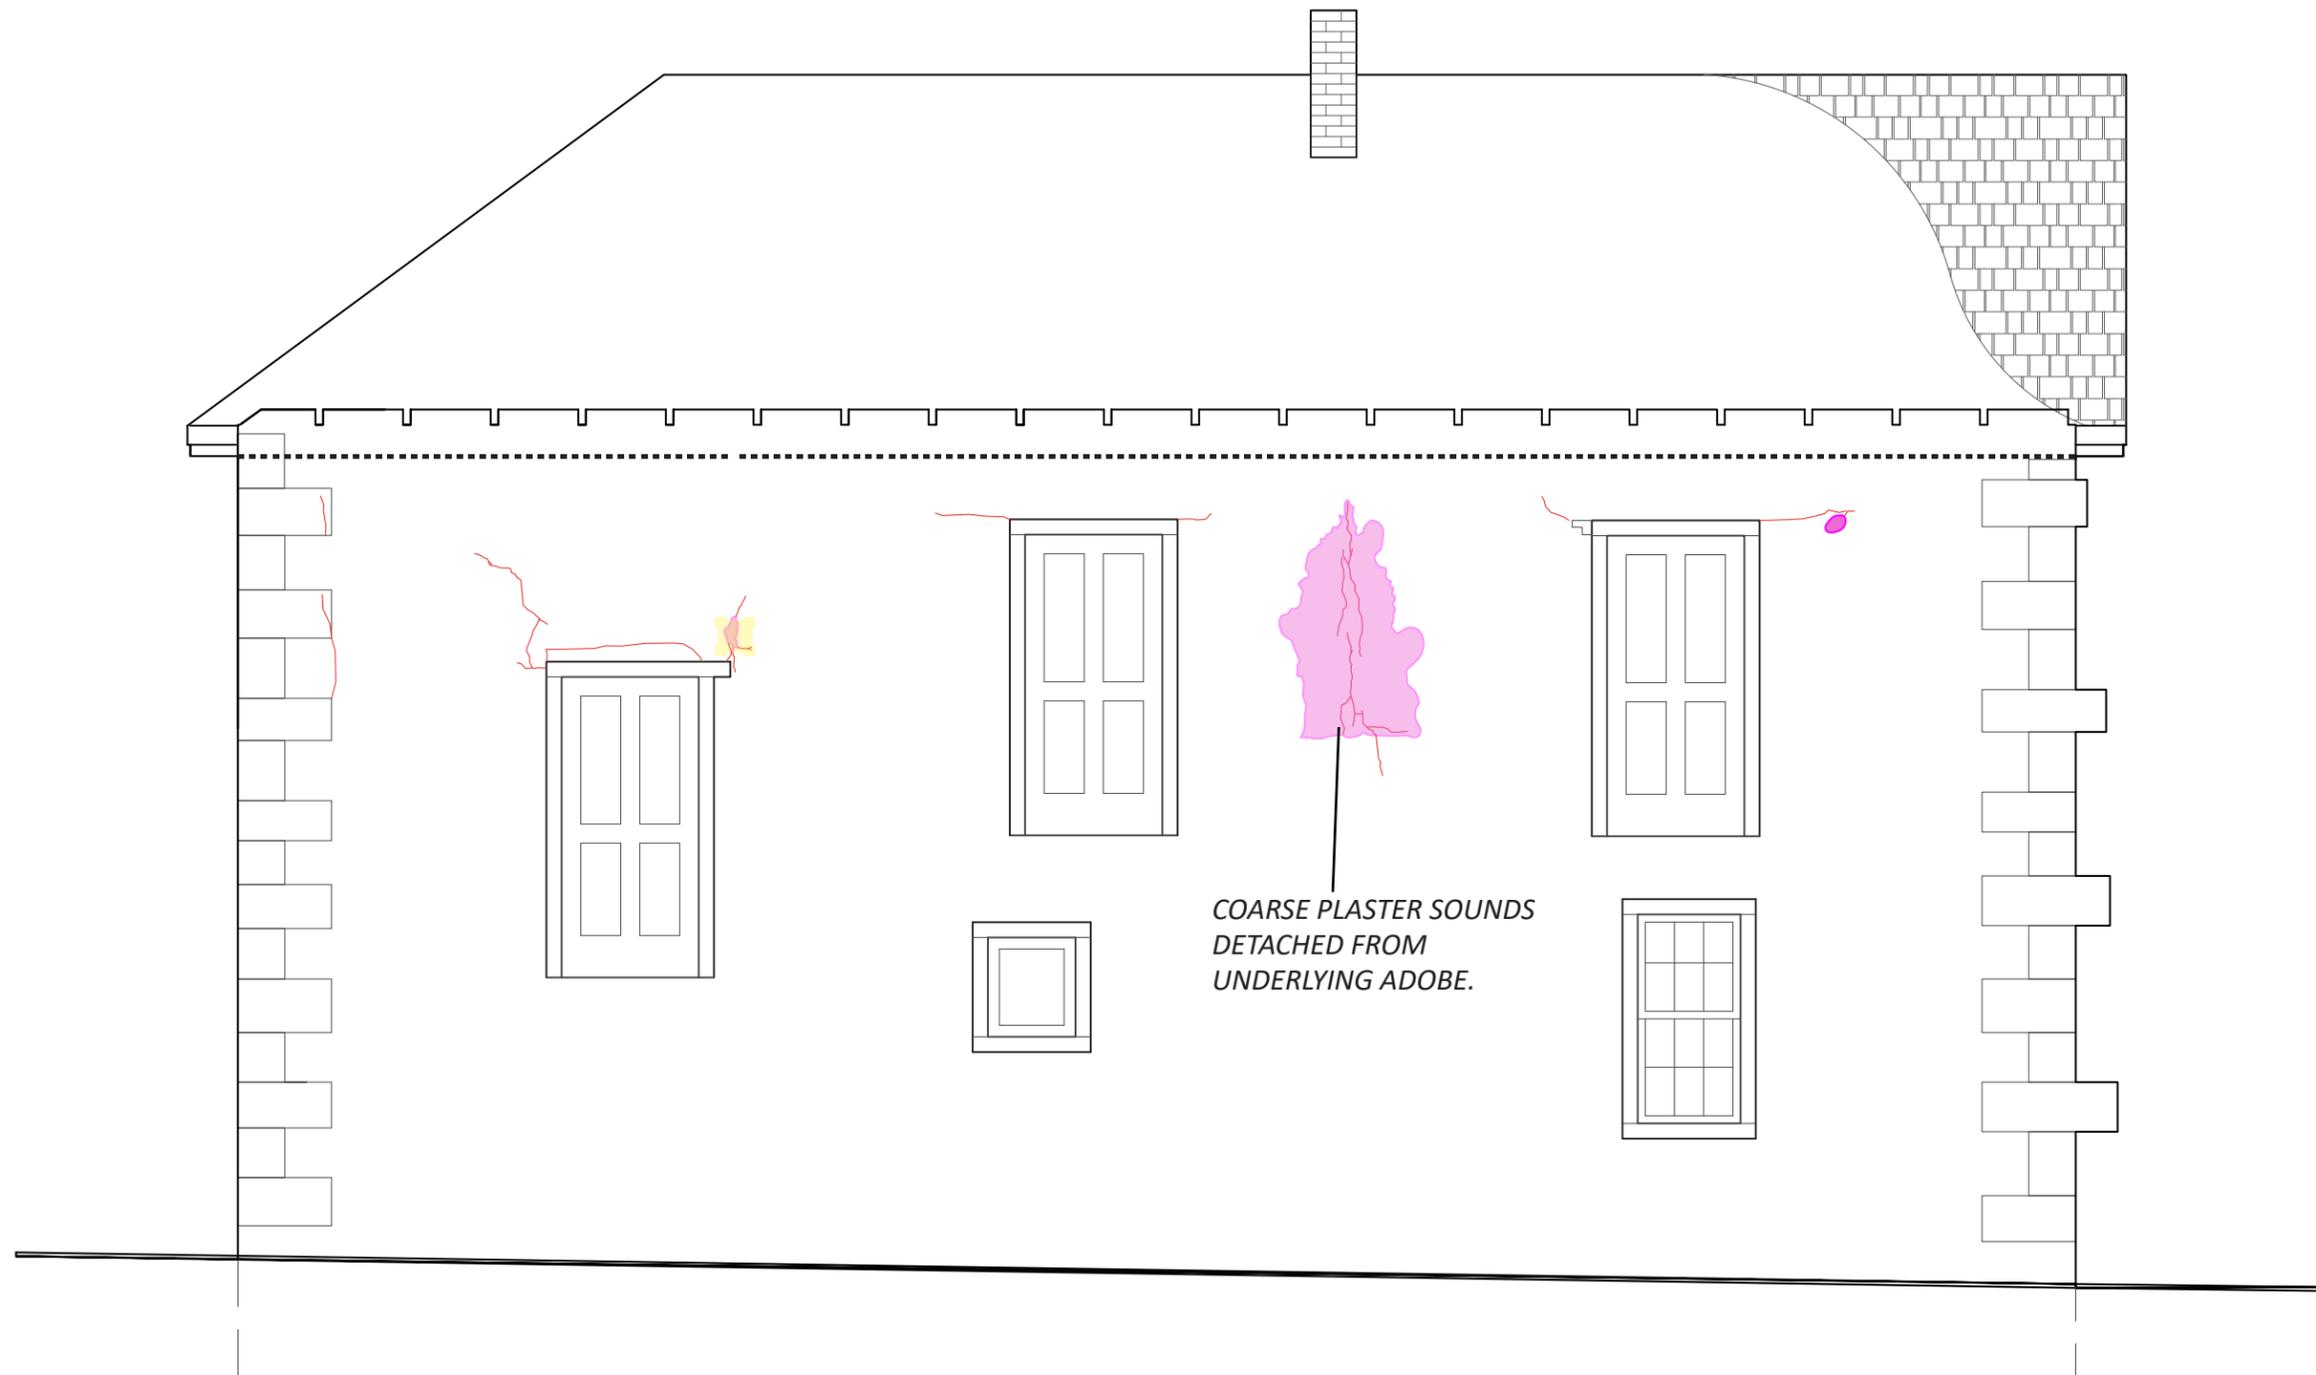
TITLE OF SHEET:
CONDITIONS DRAWINGS
North Elevation

CONDITIONS DENOTED IN THESE
DRAWINGS ARE BASED ON VISUAL
SURVEY ONLY.

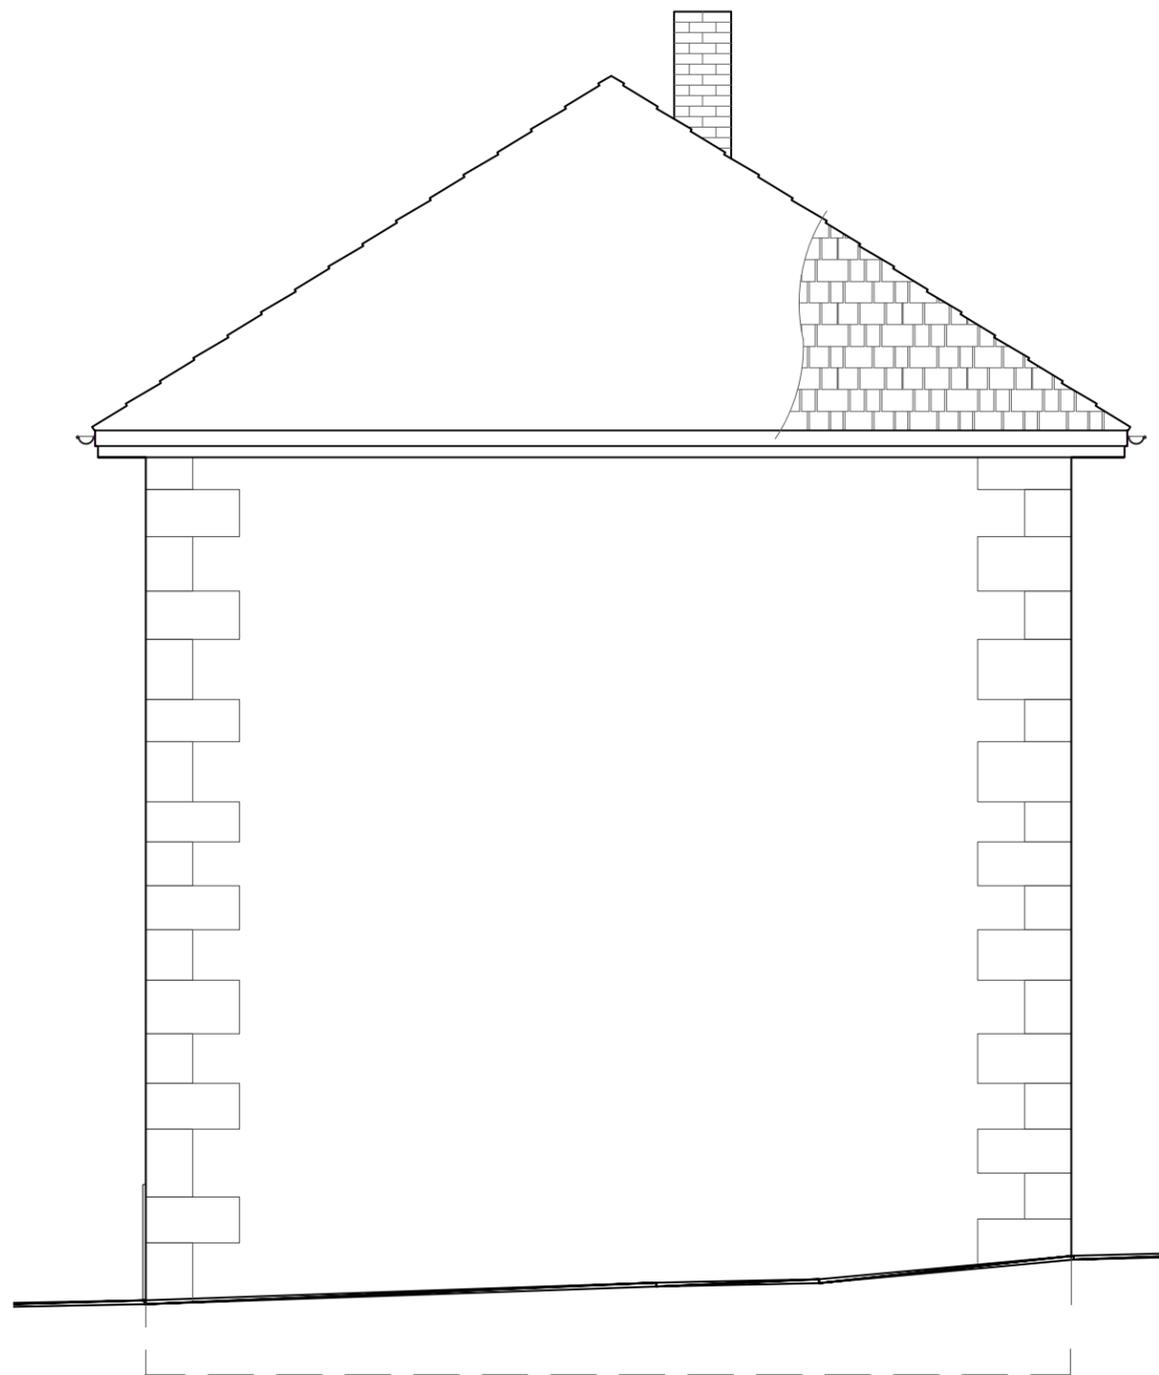
EAST ELEVATION

CONDITIONS DENOTED IN THESE
DRAWINGS ARE BASED ON VISUAL
SURVEY ONLY.
