## Pleasant View Church & Quince Orchard Schoolhouse

*Pleasant View Historical Association*  
*North Potomac, Maryland*  
Structural Condition Assessment

Prepared For:  
Preservation Maryland

April 14, 2016

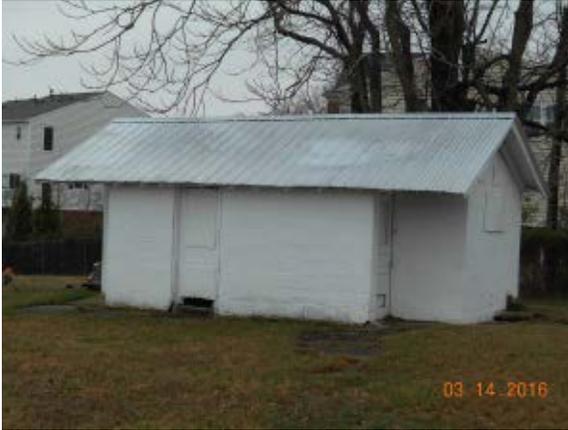
The origin of the existing outhouse building is unknown; however, the building appears to have been constructed between the late 1920's and 1940s. The structure sits on a concrete foundation with a below grade cellar. The cellar is covered by a concrete slab with concrete masonry unit walls. The roof is framed with timber protected by a metal roof. Cracking in the joints of the concrete masonry walls were observed on the south

elevation. The building was locked and interior access to the building was not available at the time of the site visit.

Figure 26: Outhouse Building.
